Selection & Maintenance of Natural Stone Tile Floors

Richard P. Goldberg AIA, CSI

Architect – Professional Consultants International

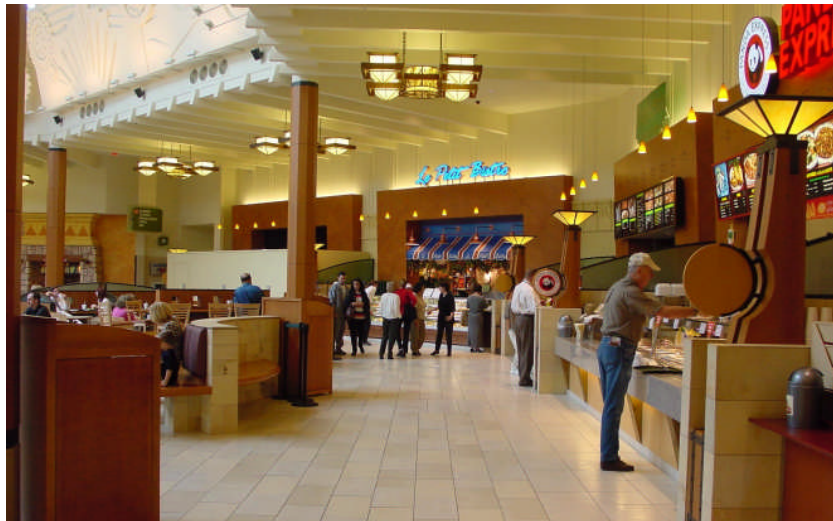
Figure 1 – honed limestone tile sealed with penetrating sealer provides a soft, natural look that is safe and easy to maintain in a retail food court environment

The development of deep-penetrating, water-based silane sealers has revolutionized control of staining and ease of cleaning more absorptive natural stone materials. Silane, a derivative of silicon, has a very small molecular size, and can penetrate deeply into stone pores, where it chemically reacts and develops a strong bond, repelling water, oils or other contaminating liquids. This strong chemical bond, together with deep penetration beneath the stone surface, creates durable, long-lasting protection from daily stone surface maintenance or abrasion, as well as protection from weather or damaging sun exposure. There typically is no change in stone appearance or texture, although these types of products can also be formulated to enhance and darken natural stone, or to increase slip resistance. We’ve come a long way since the Roman’s use of olive oil to protect and enhance stone !

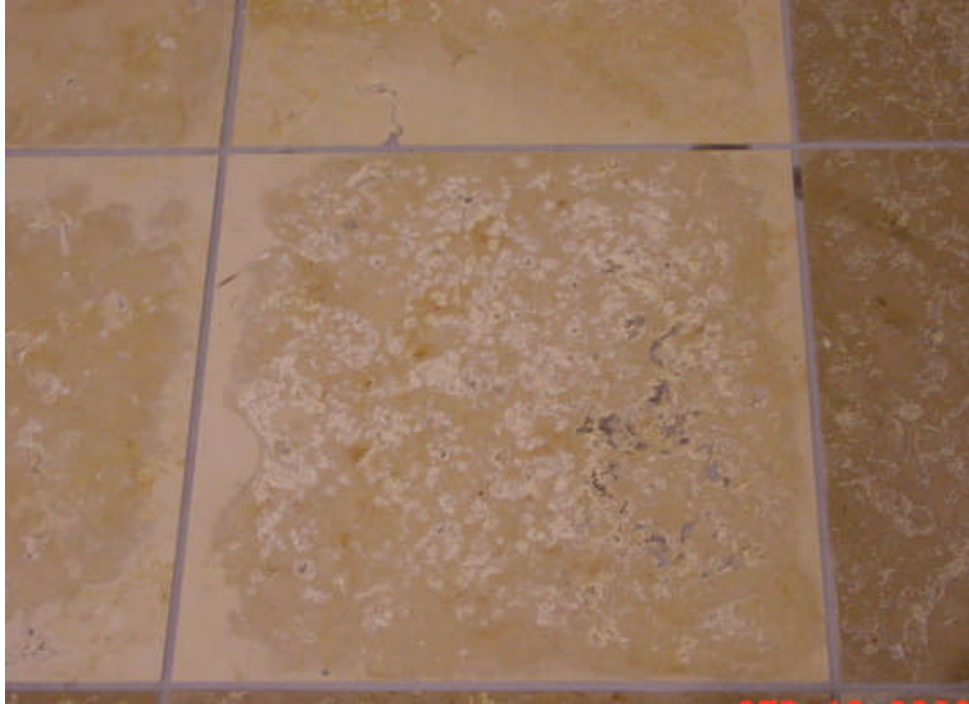
Figure 2 – honed limestone tile with reactive organic content damaged from excessive moisture exposure resulting from failure to install vapor retarder

There are also physical attributes of stone, such as moisture sensitivity, for which there are no established industry test protocols. However, many industry manufacturers and consultants have devised accurate tests to evaluate this phenomenon. Certain varieties of limestone, prized for color or texture from certain mineral or organic content, are notorious for becoming dimensionally unstable or subject to deterioration as a result of prolonged moisture exposure. Moisture sources can be obvious (water leaks from food tenants or unprotected fountains / planters), or more subtle sources (residual construction / installation moisture or daily maintenance water absorption). In some cases, a particular stone variety may not be problematic until the stone is fabricated into thin 3/8 inch (10 mm) tiles with large area dimensions (12 x 24 or 18 x 18 inches).

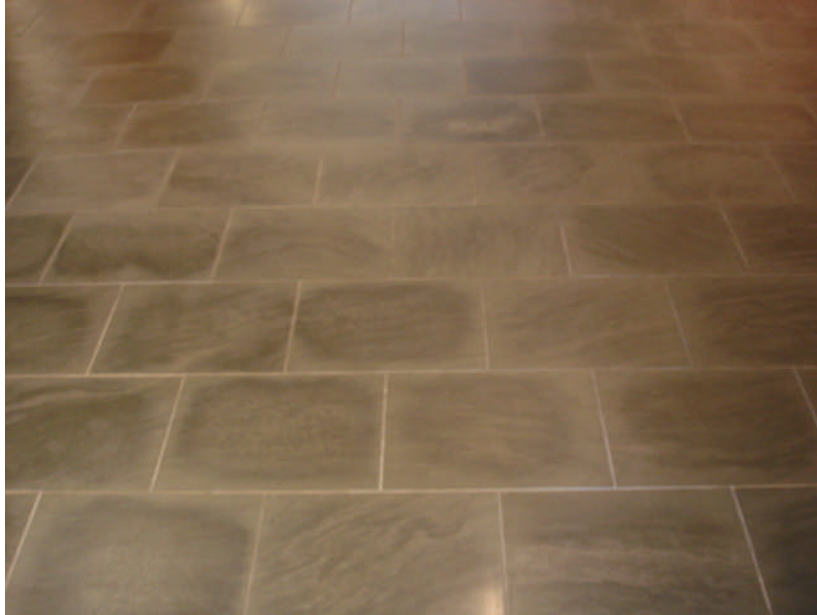
Figure 3 – discoloration of honed Pietro di Cardoza sandstone caused by prolonged exposure to residual adhesive moisture after installation over an impermeable crack-isolation membrane; note the “halo” at the perimeter where moisture escapes through grout joints

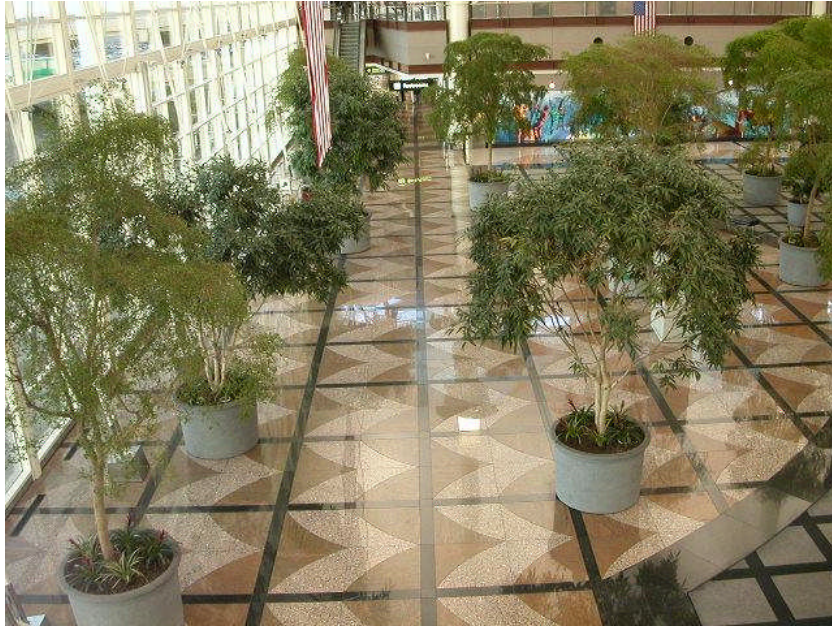
Figure 4 – polished finish granite is durable in high-traffic airport retail area, but even hard, dense stones will eventually show wear

Eventually, natural stone tile will show wear in high-traffic areas; but one of the advantages of natural stone is that the surface can be re-finished to repair normal wear and tear or minor damage. However, any re-finishing of natural stone must be done by physical grinding of the stone surface with diamond pads or other abrasive compounds; there are no "quick-fix" methods without risks, despite many commercial claims. It is strongly recommended to avoid any type of re-finishing methods for marble or limestone commonly known as vitrification or re-crystallization. This re-finishing method actually changes the physical composition of the stone, as acid chemicals are used to break down the calcium carbonate surface of the stone and combine the calcium with other compounds to form a new, impervious, enamel-like film over the surface of the stone. Once the pores of the stone surface are blocked, moisture vapor can become encapsulated and cause deterioration or dimensional instability of the stone.
