## ***Selection & Maintenance of Natural Stone Tile Floors***

**Richard P. Goldberg AIA, CSI**

**Architect – Professional Consultants International**

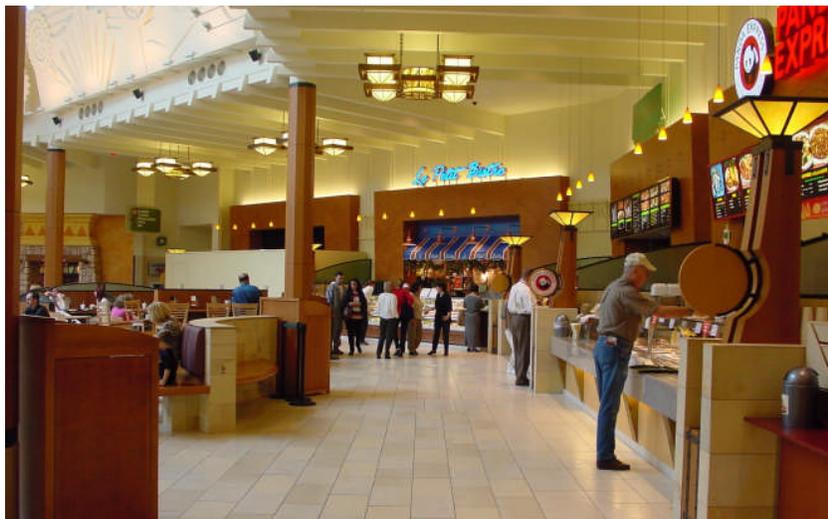
Figure 1 – honed limestone tile sealed with penetrating sealer provides a soft, natural look that is safe and easy to maintain in a retail food court environment

The development of deep-penetrating, water-based silane sealers has revolutionized control of staining and ease of cleaning more absorptive natural stone materials. Silane, a derivative of silicon, has a very small molecular size, and can penetrate deeply into stone pores, where it chemically reacts and develops a strong bond, repelling water, oils or other contaminating liquids. This strong chemical bond, together with deep penetration beneath the stone surface, creates durable, long-lasting protection from daily stone surface maintenance or abrasion, as well as protection from weather or damaging sun exposure. There typically is no change in stone appearance or texture, although these types of products can also be formulated to enhance and darken natural stone, or to increase slip resistance. We’ve come a long way since the Roman’s use of olive oil to protect and enhance stone !

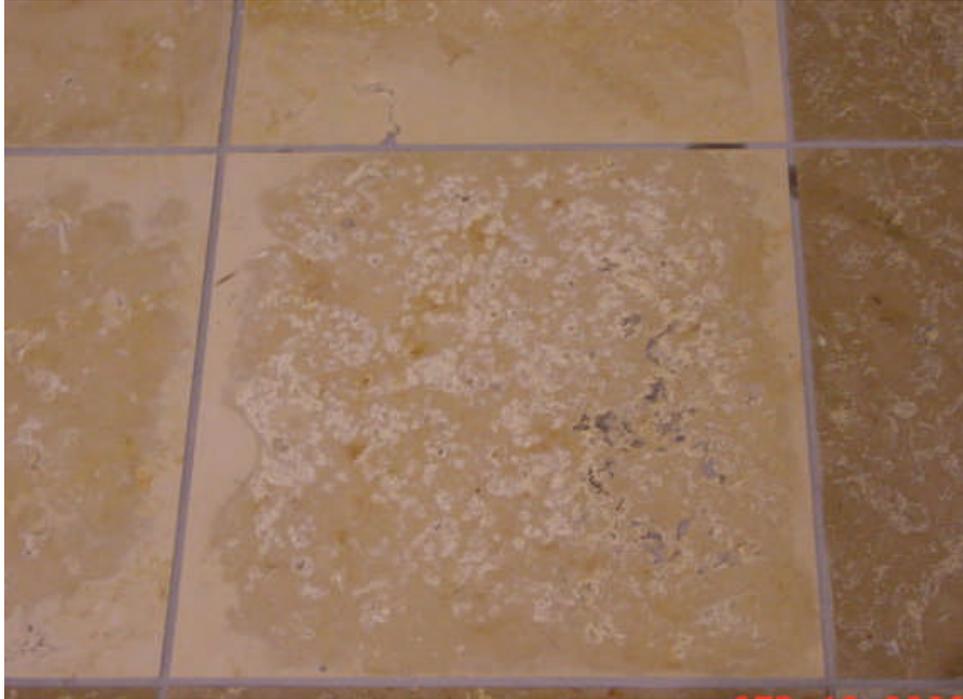
Figure 2 – honed limestone tile with reactive organic content damaged from excessive moisture exposure resulting from failure to install vapor retarder

There are also physical attributes of stone, such as moisture sensitivity, for which there are no established industry test protocols. However, many industry manufacturers and consultants have devised accurate tests to evaluate this phenomenon. Certain varieties of limestone, prized for color or texture from certain mineral or organic content, are notorious for becoming dimensionally unstable or subject to deterioration as a result of prolonged moisture exposure. Moisture sources can be obvious (water leaks from food tenants or unprotected fountains / planters), or more subtle sources (residual construction / installation moisture or daily maintenance water absorption). In some cases, a particular stone variety may not be problematic until the stone is fabricated into thin 3/8 inch (10 mm) tiles with large area dimensions (12 x 24 or 18 x 18 inches).

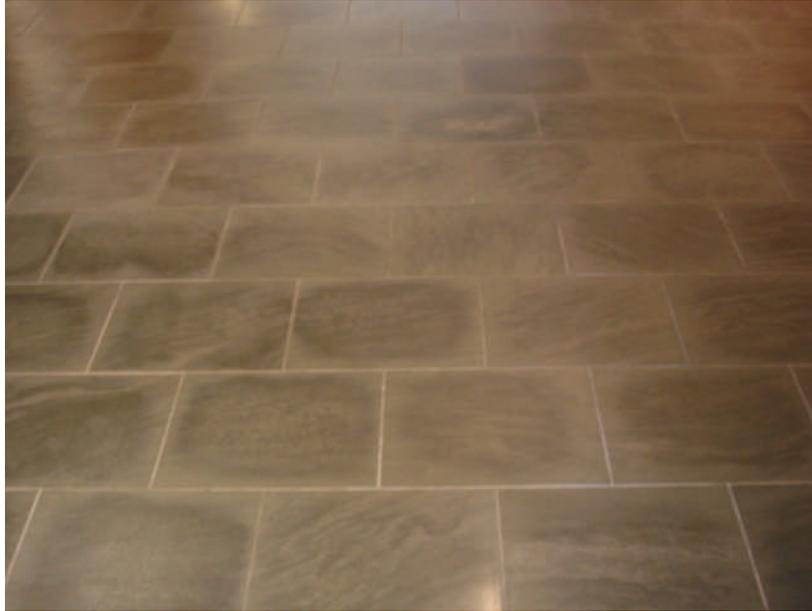
Figure 3 – discoloration of honed Pietro di Cardoza sandstone caused by prolonged exposure to residual adhesive moisture after installation over an impermeable crack-isolation membrane; note the “halo” at the perimeter where moisture escapes through grout joints

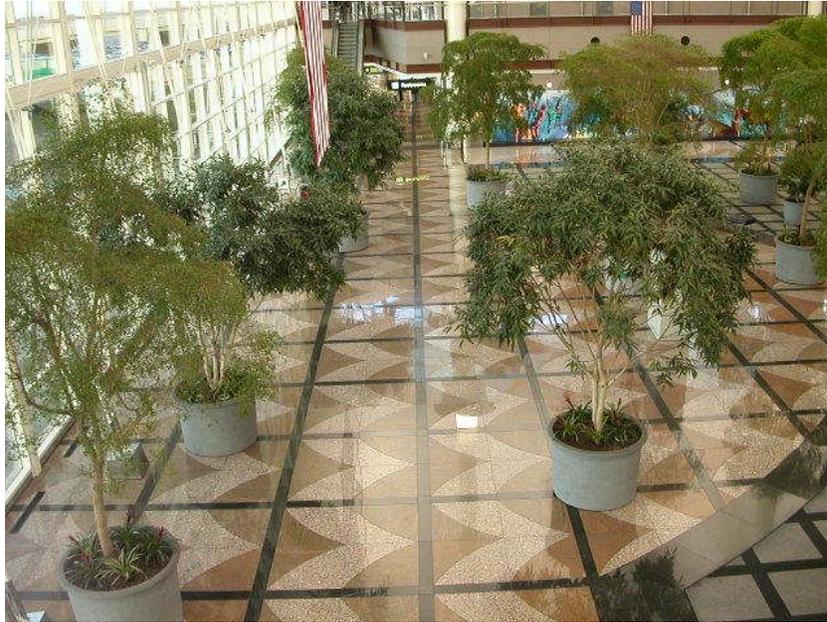
Figure 4 – polished finish granite is durable in high-traffic airport retail area, but even hard, dense stones will eventually show wear

Eventually, natural stone tile will show wear in high-traffic areas; but one of the advantages of natural stone is that the surface can be re-finished to repair normal wear and tear or minor damage. However, any re-finishing of natural stone must be done by physical grinding of the stone surface with diamond pads or other abrasive compounds; there are no "quick-fix" methods without risks, despite many commercial claims. It is strongly recommended to avoid any type of re-finishing methods for marble or limestone commonly known as vitrification or re-crystallization. This re-finishing method actually changes the physical composition of the stone, as acid chemicals are used to break down the calcium carbonate surface of the stone and combine the calcium with other compounds to form a new, impervious, enamel-like film over the surface of the stone. Once the pores of the stone surface are blocked, moisture vapor can become encapsulated and cause deterioration or dimensional instability of the stone.
